DATA REPORT

Wyckoff/Eagle Harbor Evaluation of Sediment Cap Condition at East Harbor Operable Unit

August 28, 2014

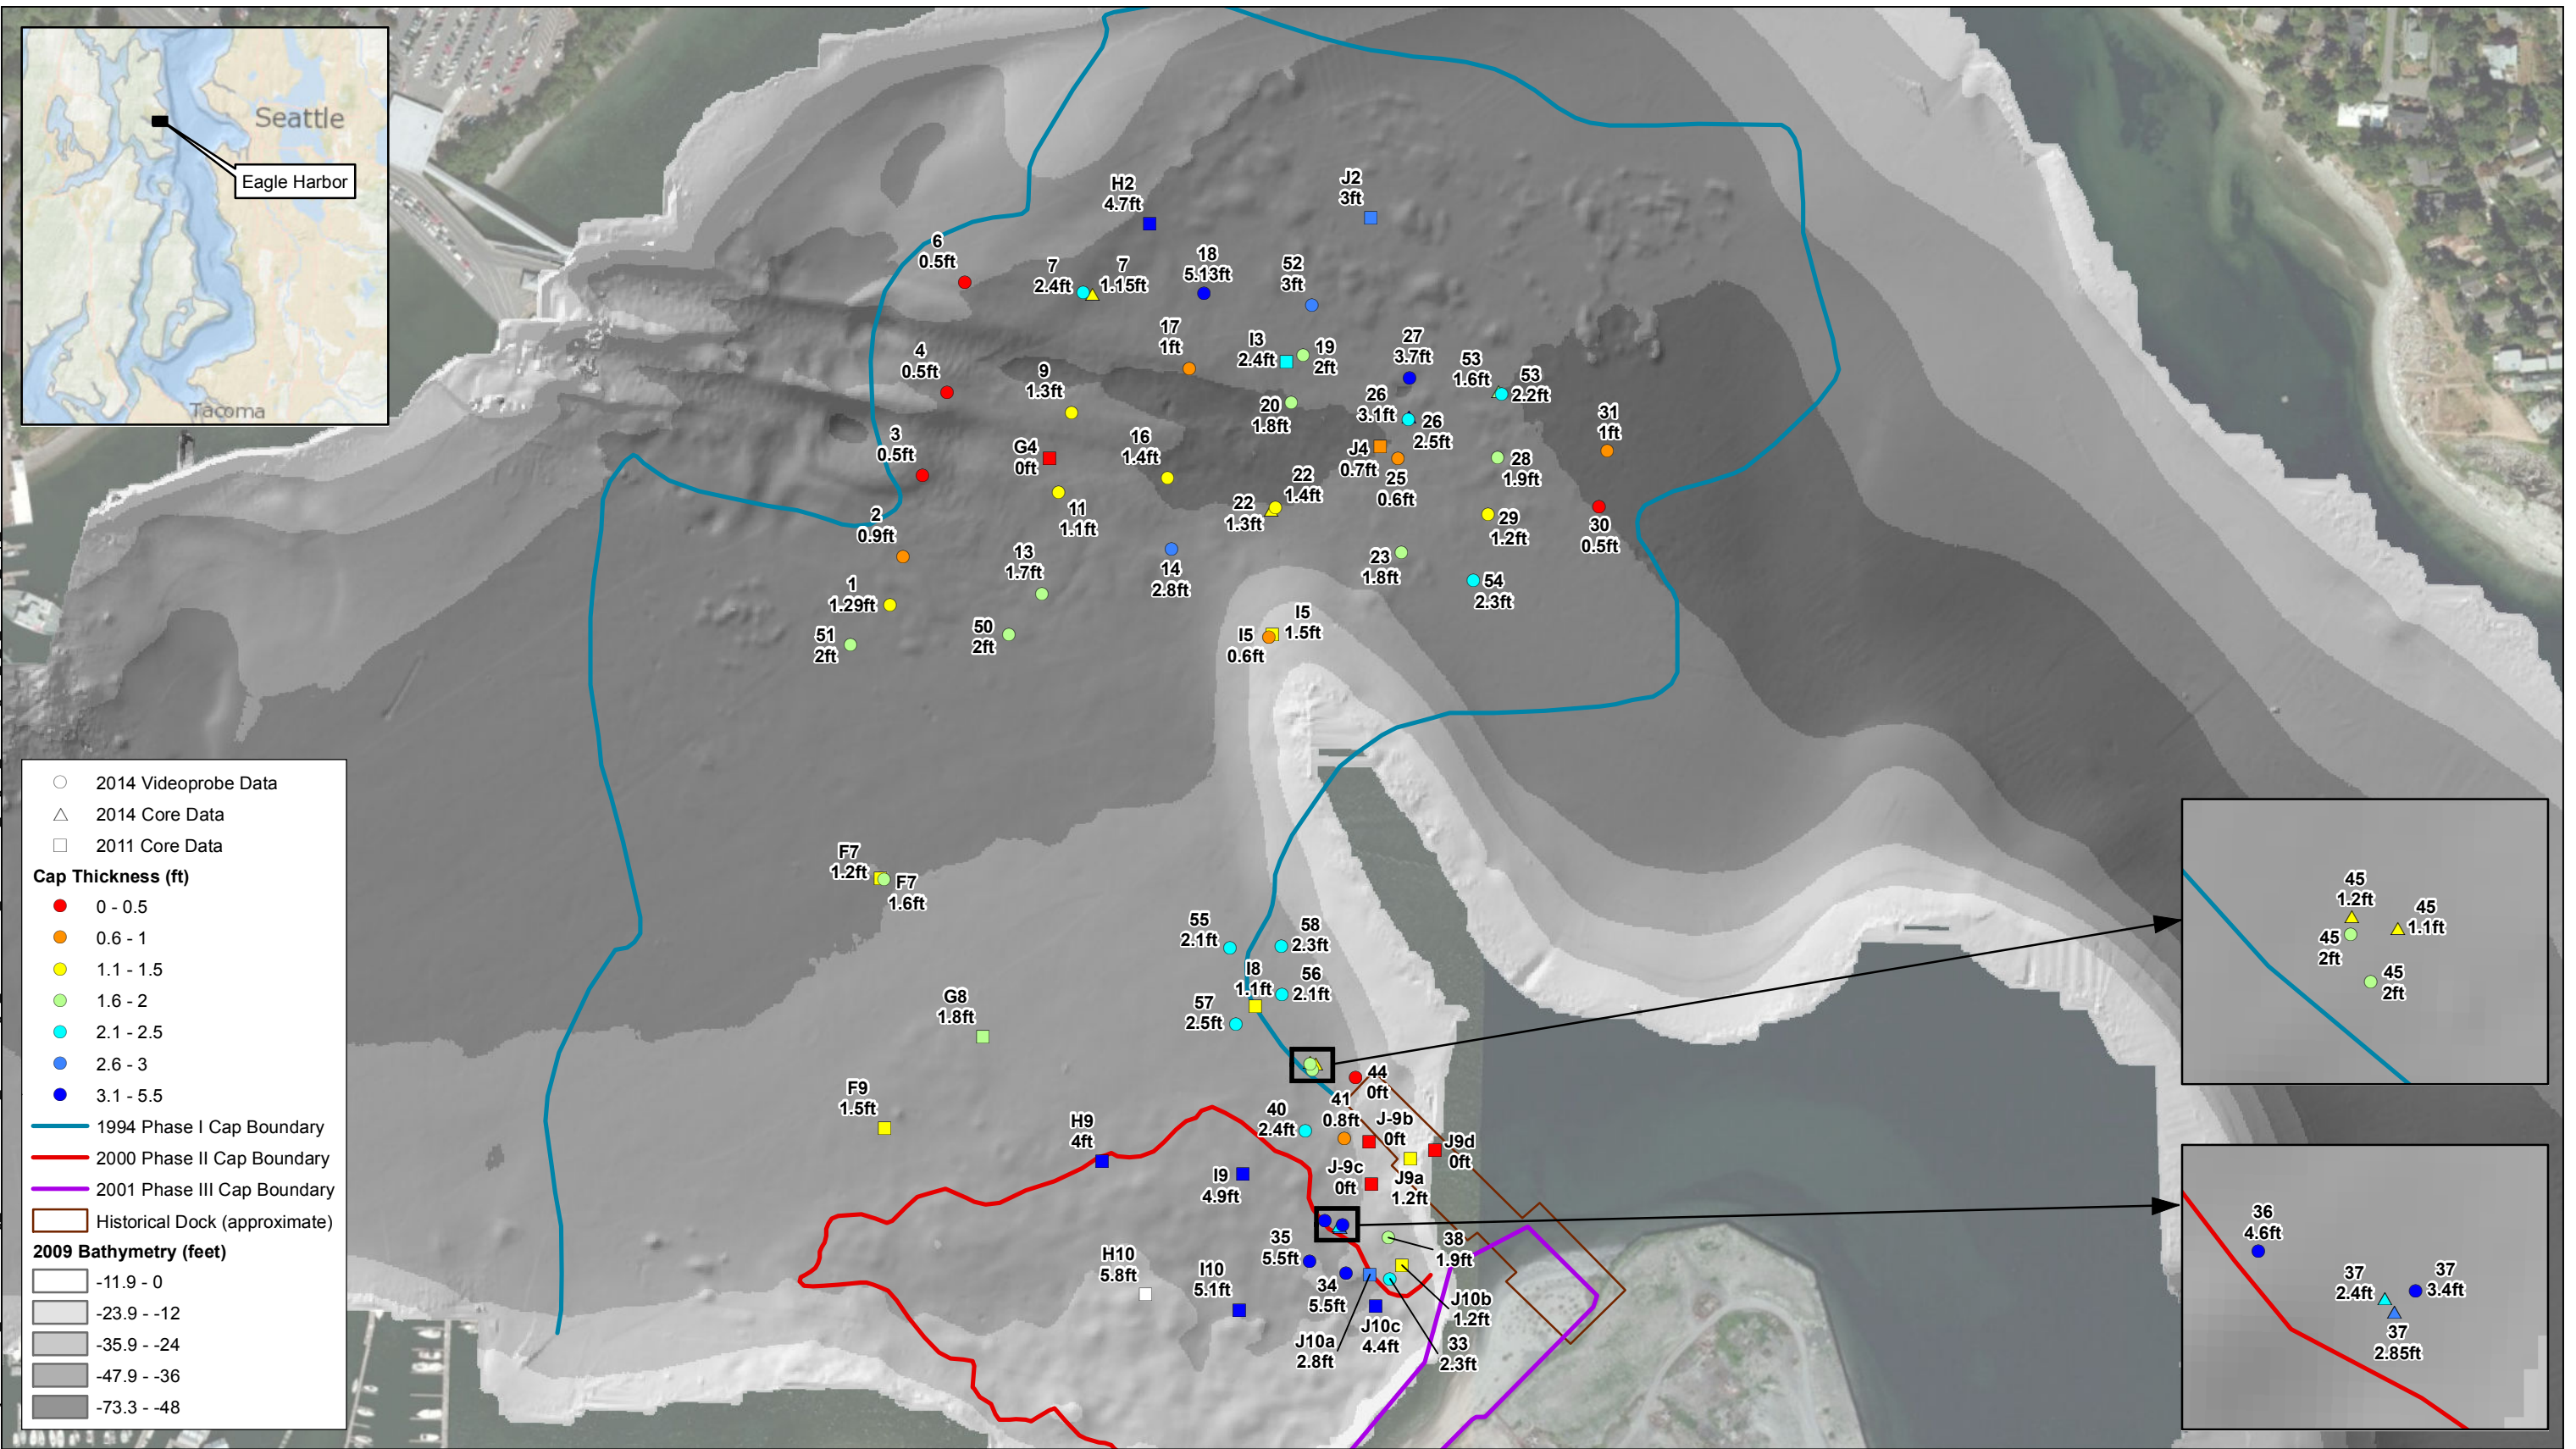
Figure 3-1.
Cap Thickness Data

The available data sets of cap thickness measurements from 2014 and 2011 were combined and are presented in Figure 3-1. The mapped data include 75 measurements from the 46 videoprobes and 8 vibracores collected for this investigation, as well as those from 21 vibracores collected during the 2011 monitoring event (Table 3-1). As shown, most of the data are located in the area of the ferry lane and the J9/J10 area.

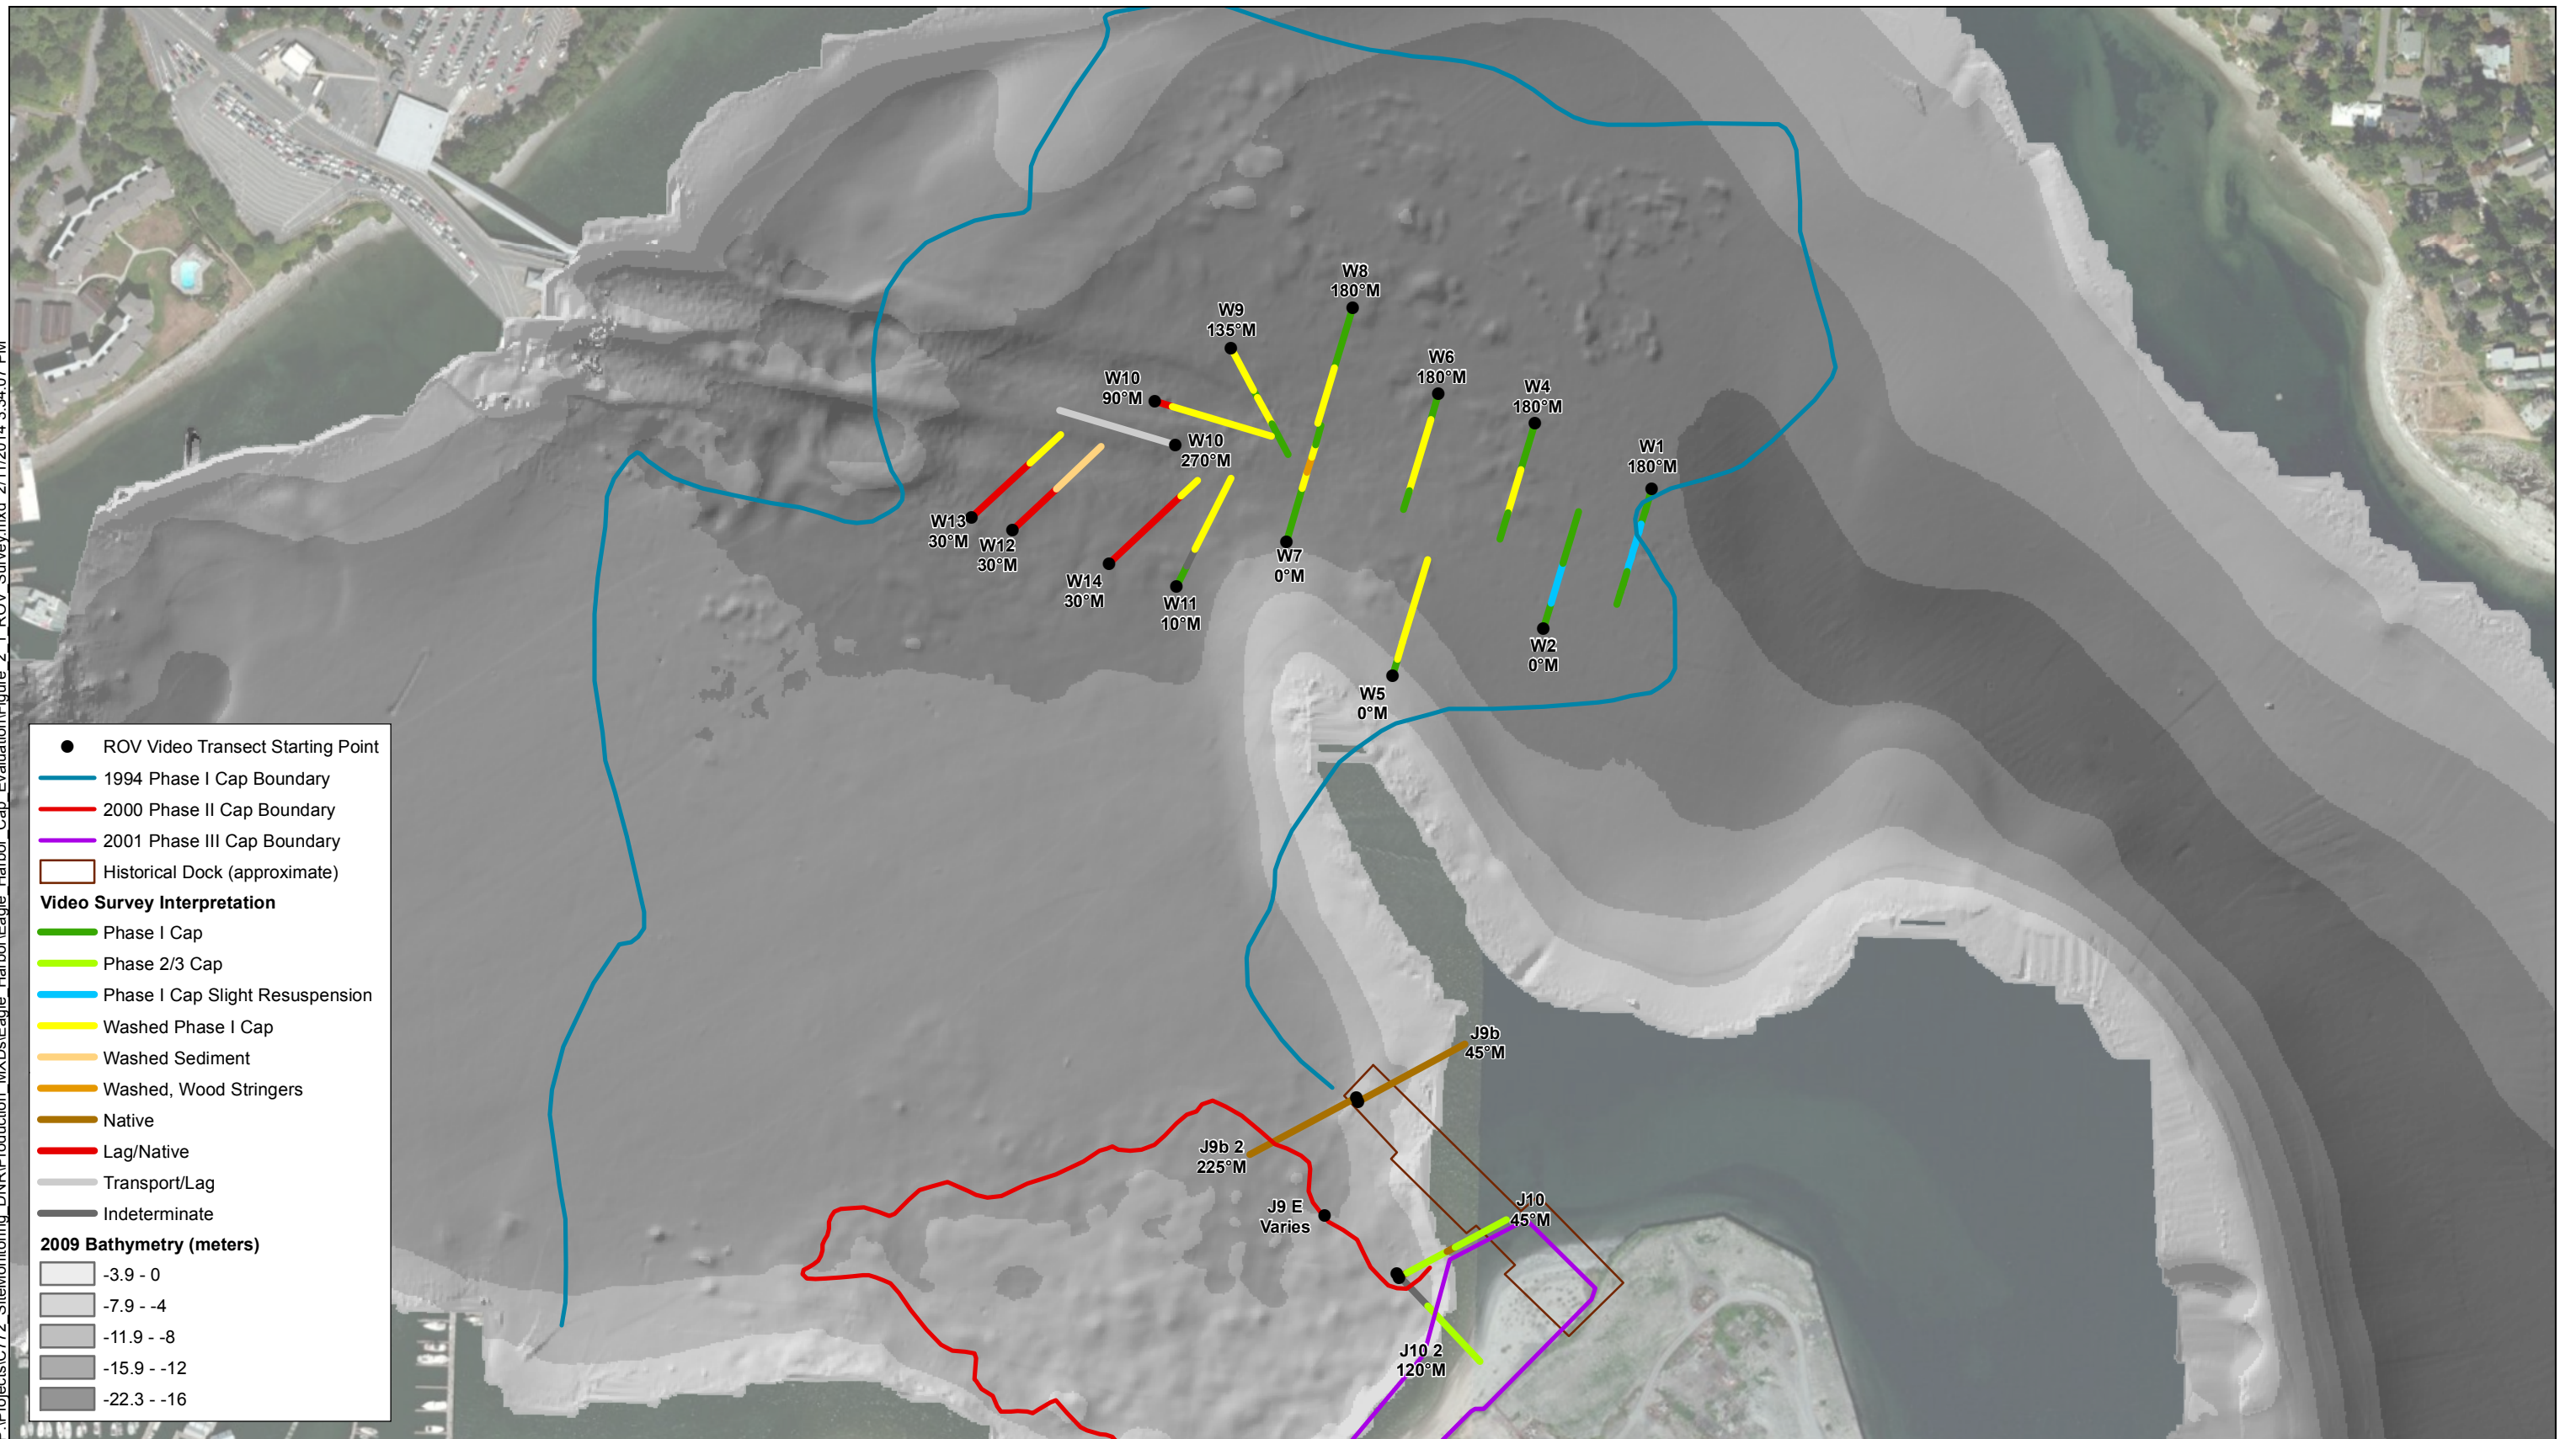
Figure 2-1.
Results of ROV Video Survey

The first phase of this investigation involved the use of EPA's ROV to conduct a video survey of the bottom conditions in the area off the ferry dock and in area J9/J10. The ROV survey was conducted on October 30 and 31, 2013, along 19 transects—14 in the Phase 1 cap area along the ferry path and 5 in the J9/J10 area. Observations and interpretations of surface sediment characteristics and features made by Mr. Dave Browning, the lead project geologist, during the survey are summarized in Table 2-1 and mapped in Figure 2-1. Note that due to the inability to record precise locations of the ROV as it ran the transects, the distances along transects for observations noted in the table, and the locations of features shown on the map, are approximate, and observations along the transect J9E, which followed a variable course, are not shown on Figure 2-1. In spite of the location tracking limitations, the ROV survey provided useful information on bottom surface sediment conditions, including sediment texture, bed hardness, and indicators of hydraulic reworking such as bedforms and winnowed lag deposits, that allowed an approximate location of the transition between cap/no cap conditions to be identified on most transects (Figure 2-1). These data were used in the planning of the proposed sediment coring phase of the investigation.
